T R E E R E P O R T

**TREE REPORT**  
141 N. Civic Drive  
Walnut Creek, CA

**PREPARED FOR:**  
Urban Housing Group  
777 S. California Ave.  
Palo Alto, CA 94304

March 2011

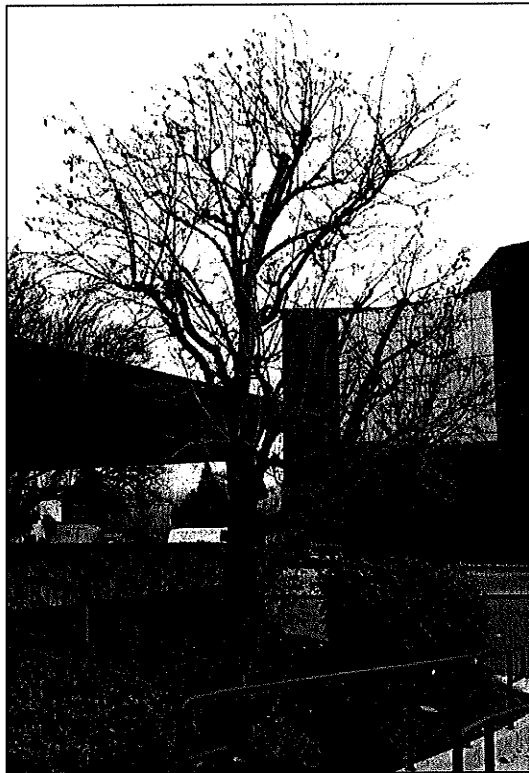
**Photo 1:** Sweetgum #17 had been topped repeatedly. The tree was representative of other sweetgums and Norway Maples surveyed at the site, the majority of which had also been topped.
