## PRELIMINARY ARBORIST REPORT

**Hall Equities  
Second & Main  
Walnut Creek, CA**

February 15, 2019

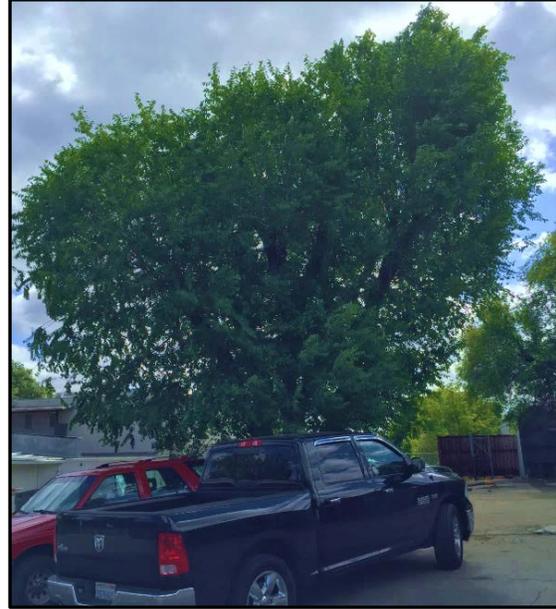
Four sawleaf zelkova trees were located in the parking lots in areas too small for the potential mature size of these trees. Three were in fair condition and one tree (#18) was in poor (photo 1). All but one were multi-trunk trees. One tree (#10) was young (5-7") and 3 were semi-mature (13-17"). The largest single trunked tree (#11) had a diameter of 18". Tree #11 had poor form and structure and had been topped.

**Photo 1 (above):** This multi-trunk Sawleaf zelkova #18 was in poor condition. The root system was displacing the parking lot.

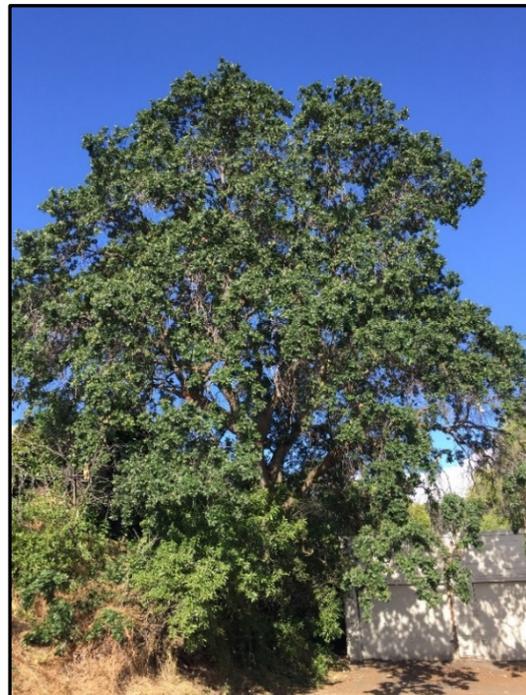
**Photo 2 (below):** Valley oak #5 was located at the toe of the berm on parcel 2 and was in good condition.
